Manhole Inspection Summary

Manhole # S45GG_035MH

Insp Date: **3/12/08 1:20 PM**

Location Address: **Preston**

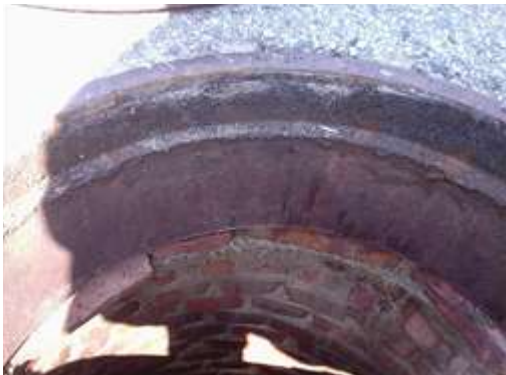
Defect 1

Condition: ☐ Sound ☐ Cracked ☐ Root Intrusion ☒ **Loose Brick** ☐ Deteriorated

adjustment joint

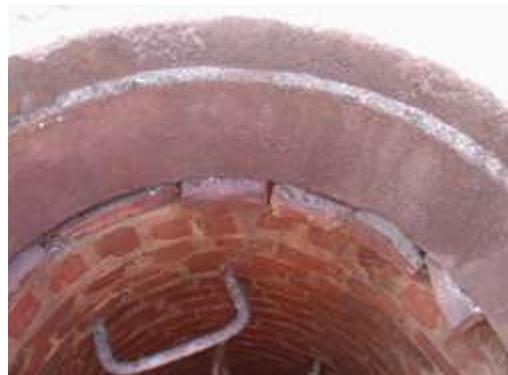
Defect 2

☒ **Leaks**

frame leaks.

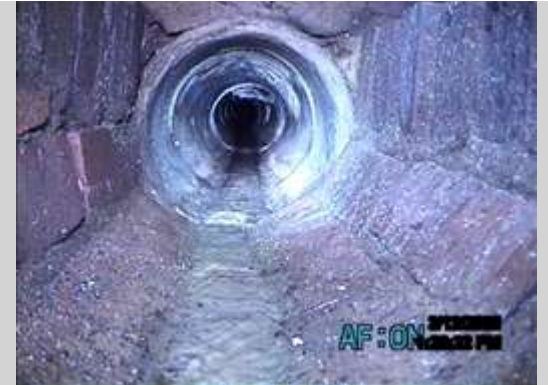
12 O'Clock Outflow

Pipe Height: **8.4** (in.) Rod and Bar (Angled)
Pipe Material: **Clay** ☐ Pipe Lined
Invert Depth: **9.50** (ft.) Flow Characteristics: **Slow**
Deposits: ☒ None ☐ Mud ☐ Sludge ☐ Debris ☐ Grease
Silt Depth: (in.) Deposits Extent:
Infiltration: **None** Pipe Seal Cond: **Sound**

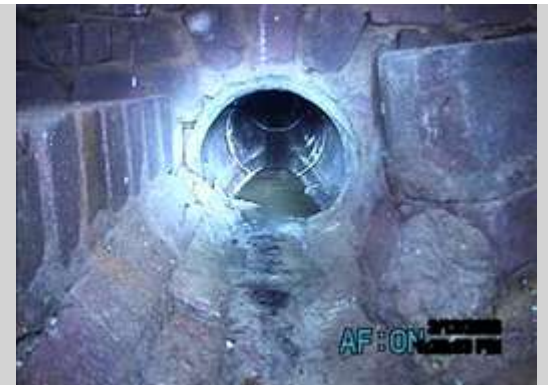
6 O'Clock Inflow

Pipe Height: **8.4** (in.) Rod and Bar (Angled)
Pipe Material: **Clay** ☐ Pipe Lined
Invert Depth: **9.45** (ft.) Flow Characteristics: **Slow**
Deposits: ☒ None ☐ Mud ☐ Sludge ☐ Debris ☐ Grease
Silt Depth: (in.) Deposits Extent:
Infiltration: **None** Pipe Seal Cond: **Sound**

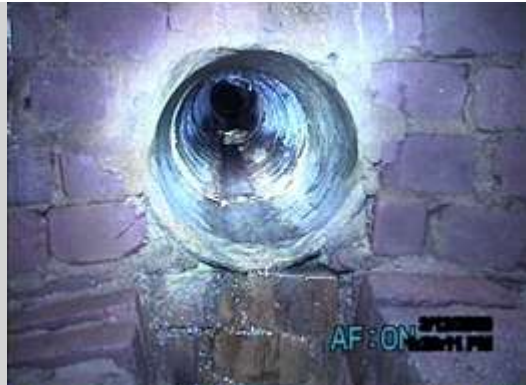
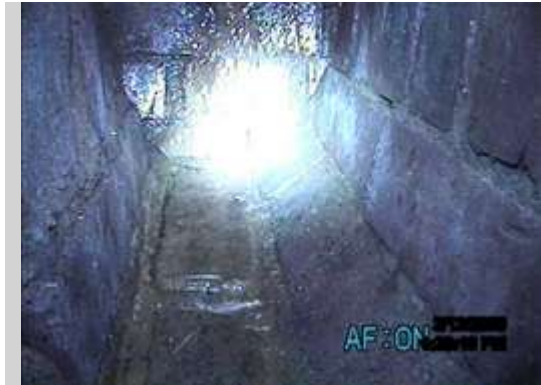
8 O'Clock Inflow

Outside drop.

Drop: **Outside** Rod and Bar

Drop Condition: **Open**
